# A Case of Camber and Gravity

**By Josh Wallace**

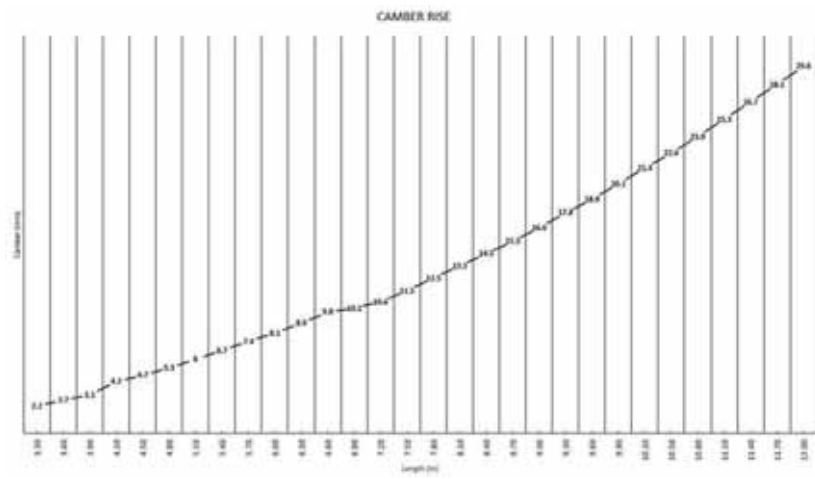
bered' or 'straight'. The industry standard camber is a 600m radius which provides a slight curve in the beam which is mostly eliminated once the load is applied. A good 'carpenter's eye' will easily pick the topside of a beam, however a 600m radius is very gradual. As an example, the mm rise at the chord midpoint to the underside of the beam is in theory, only 2.2mm on a 3.3m long beam, 8.1mm on a 6.0m long beam and 29.6mm on a 12.0m beam. Notwithstanding the likelihood of most carpenters installing beam correctly, GLTAA accredited manufacturers mark the top-side of the beam with a sticker or inked pattern.

■ Graph representing a 600m Radius Camber relevant to certain lengths.

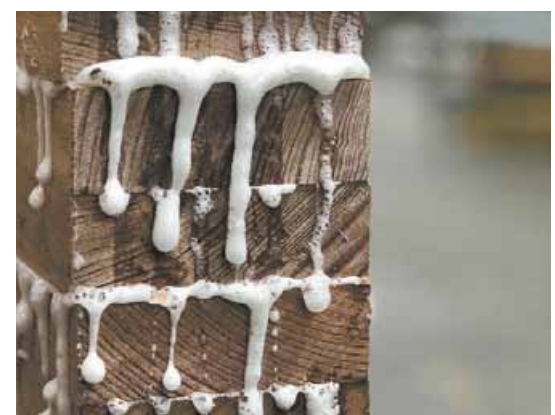
my delight, whilst one end had been cleanly cut with a power saw, the other end was untouched and still had hardened glue on the end from the factory floor. Manoeuvring the offcut in position, it was able to be lined up exactly with the end of the beam in situ - laminate for laminate, grain to grain, knot to knot... a perfect match.

ured vertically, meaning that when a beam is laid up laminate by laminate in the press, the laminates bow over the camber stick forming the gradual 600m radial arc. This also means that as the required pressure is slowly applied, a certain amount of glue is squeezed out and beads run down the end grain coagulating into goblets of glue which harden in position.

A group of us stood back. The glue runs told the story. Either gravity had been defied in my factory that day and I could now expect the men in black to swoop in or... the beam had indeed been installed upside down and the topside sticker surreptitiously removed after the fact. It was a sweet moment... I ducked outside "to make a phone call" leaving the car-

■ Glue runs on ends of beams from factory.

So, look out for those 'topside stickers' or ink patterns! Manufacturers under the GLTAA's quality accreditation scheme will also have the GLTAA logo clearly marked on the topside of the beam providing extra reassurance.
